The International Fujita (IF) Scale

Tornado and Wind Damage Assessment Guide

Draft version 0.1 of 15 October 2018

Authored by the IF Scale Steering Group

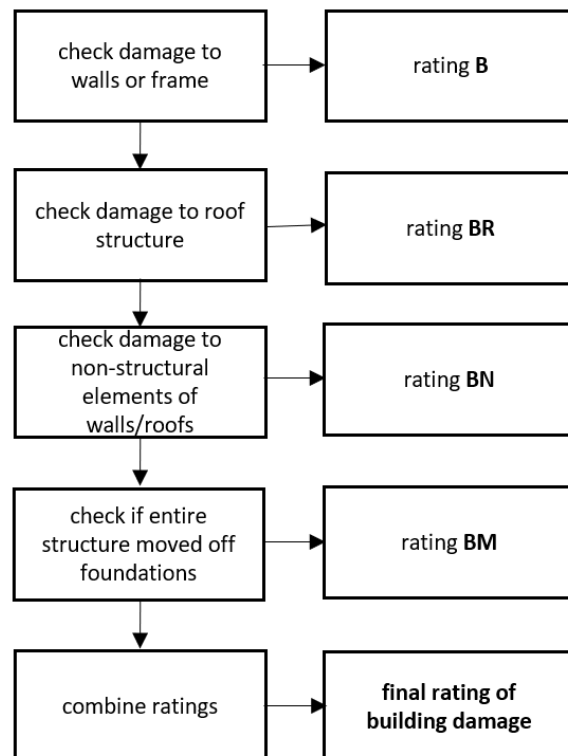
Figure 4. Flowchart for building damage assessment.

In order to obtain a rating of damage to a building, the individual ratings of the building components 1, 2 and 3 and the observation if the object has moved in its entirety have to be combined (Figure 4).

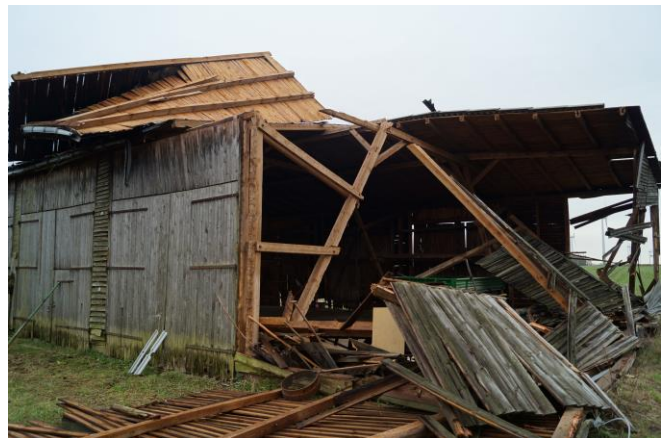
Figure 5. Damage to a shed in Barenthin, Germany on 10 November 2017. Photo: Thilo Kühne.

Shorthand: **BAB/1:1+**

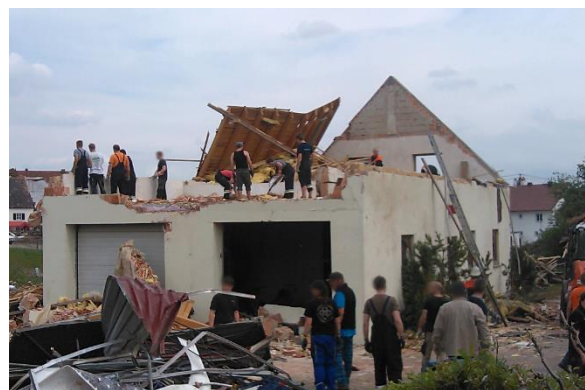
Figure 6. House deroofed by a tornado in Affing, Germany on 13 May 2015. Photo: Pieter Groenemeijer (ESSL).

Shorthand: **BRE/2:≥2+**

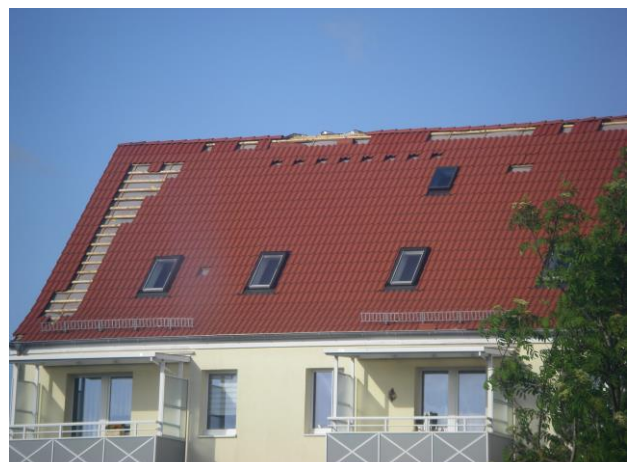
Figure 7. A roof with a number of tiles having blown off in Bützow, Germany. Photo: Thilo Kühne (ESSL).

Shorthand: **BNT+/1:1-**

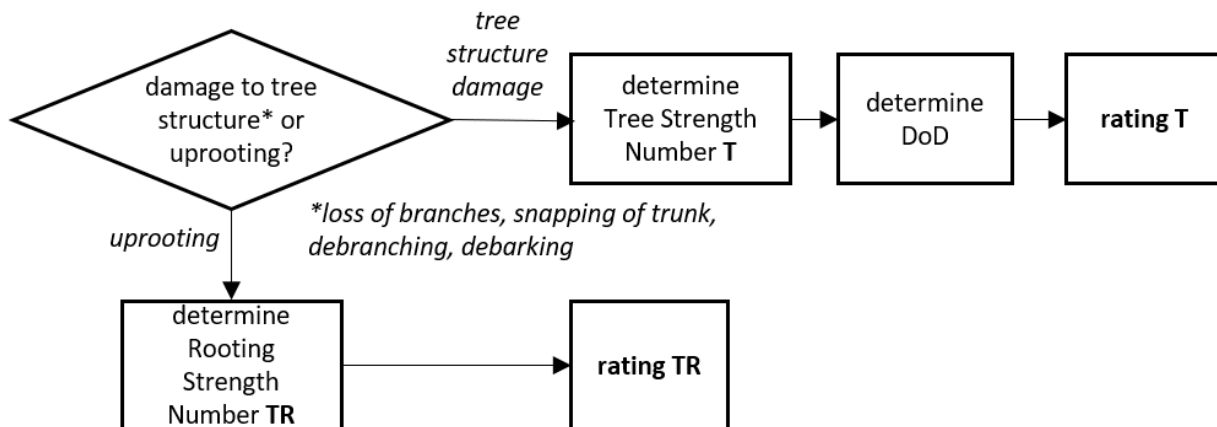
Figure 8. Flowchart to assess wind damage to trees.

Tree damage assessment begins by first determining if the tree was uprooted, or if the tree’s structure was damaged (Figure 8). These two cases represent two different damage indicators, **TR** for uprooting and **T** for damage to the tree.

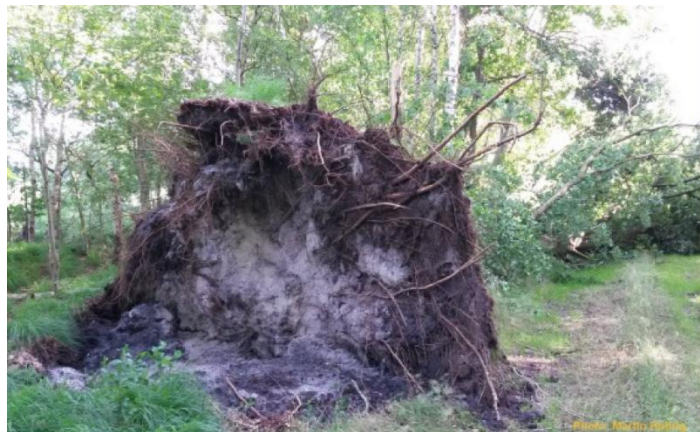
Figure 9. Uprooted oak tree. Photo: Martin Hubrig.

The T number calculation starts with 3, because oak is in the list of high firmness species. No other additions or subtractions apply, so that T=3.

To compute TR, we start with 3, and need to subtract 1 because the soil is unstable, and subtract 1, because the rooting is unusually shallow for an oak. This results in TR=1. An uprooted tree with TR leads to a rating of **IF1-**. The shorthand for this rating is **TR1/1**.

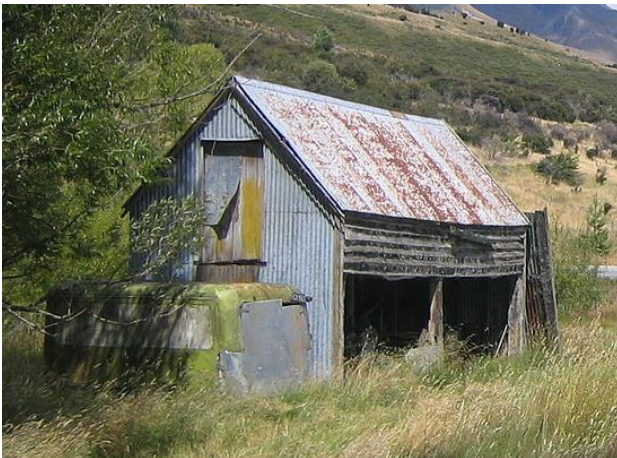
very weak frame with metal panels

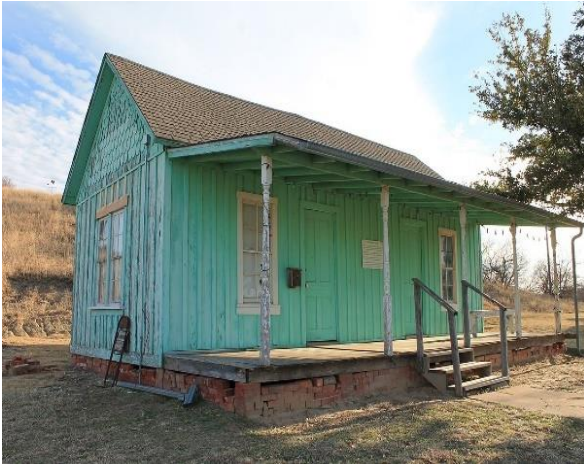
weak wooden frame with wooden panels

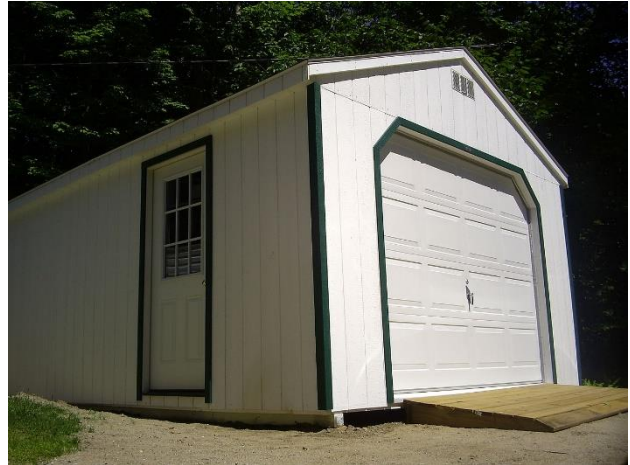
metal frame structure with wooden panels

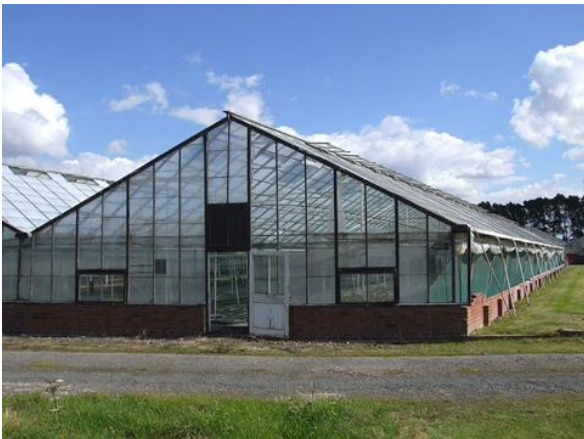
metal frame with glass panels

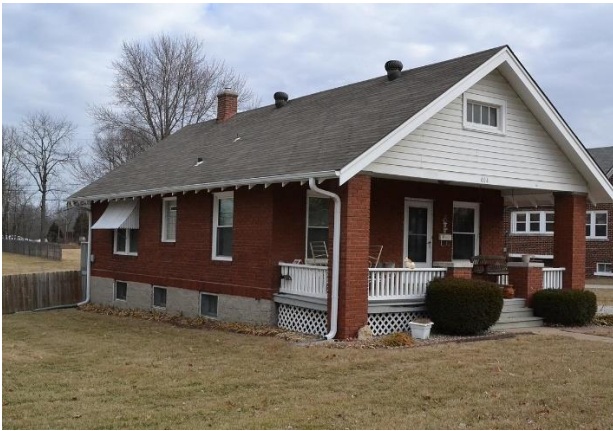
weak wooden frame structure with brick veneer

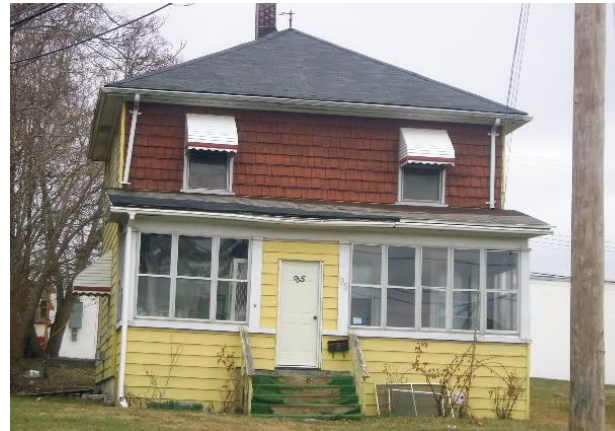
weak wooden frame structure

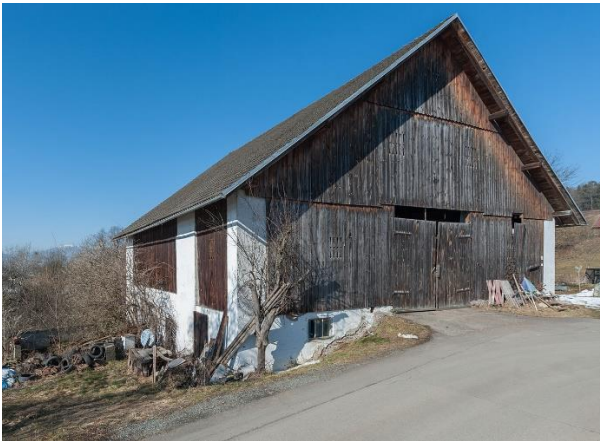
wooden frame structure with wooden panels

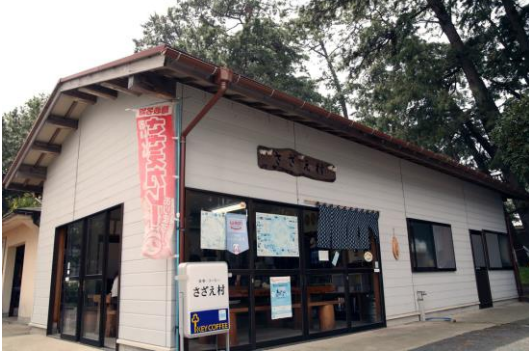
strong wooden frame structure

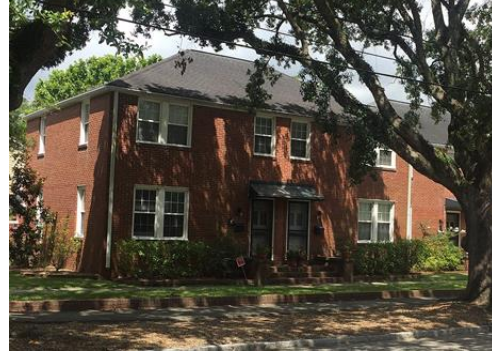
strong wooden frame structure brick veneer

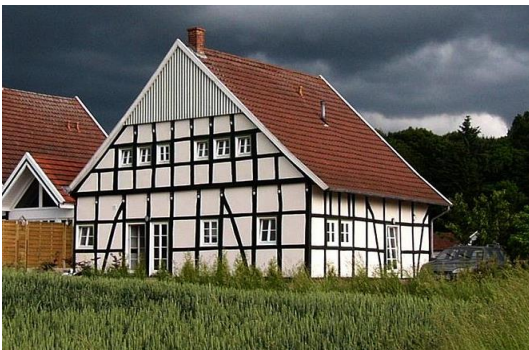
strong wooden frame structure

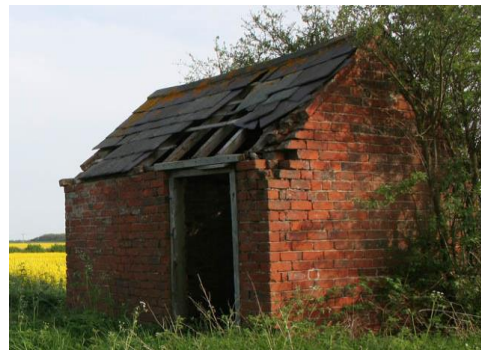
weakened brick wall structure

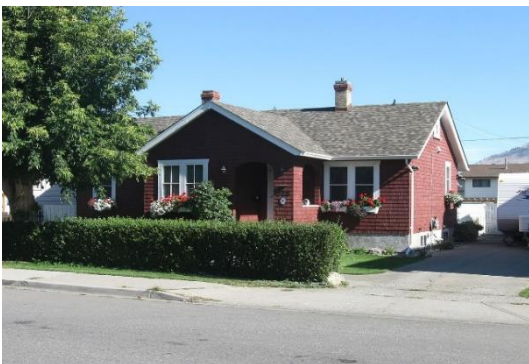
strong wooden frame structure with brick veneer

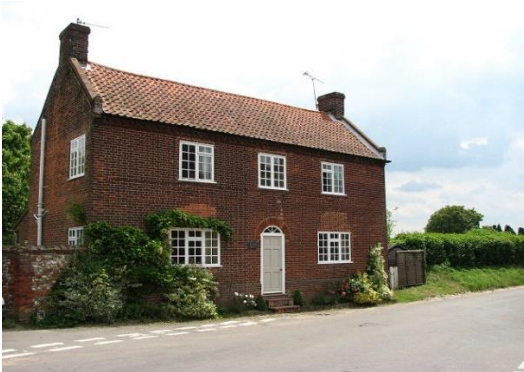
brick masonry mass wall structure

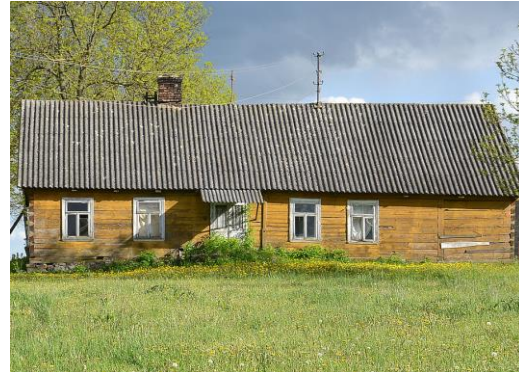
wood log (load carrying) building structure

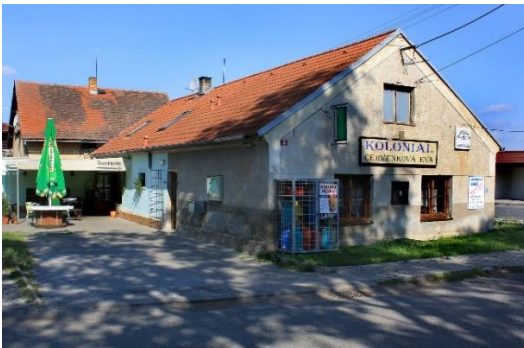
concrete block mass wall structure

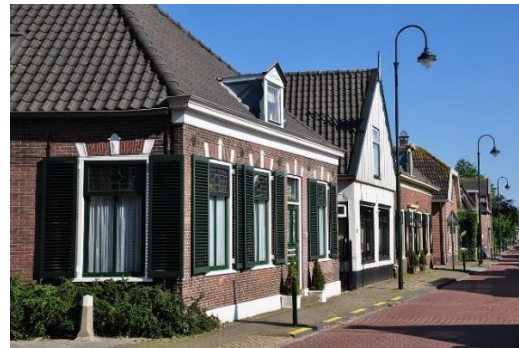
brick masonry mass wall structure

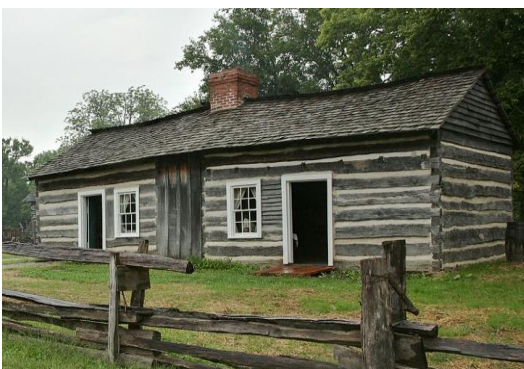
wood log (load carrying) building structure

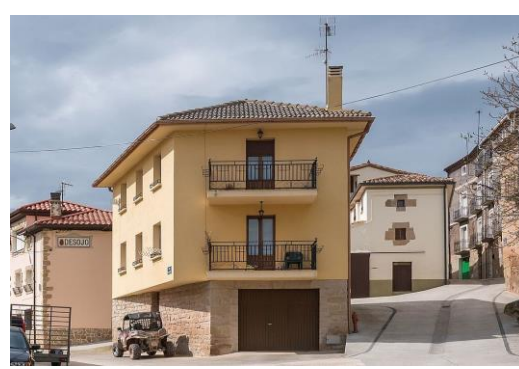
brick masonry mass wall structure

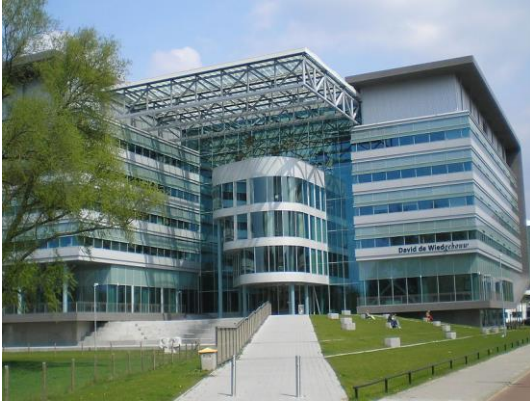
concrete structure

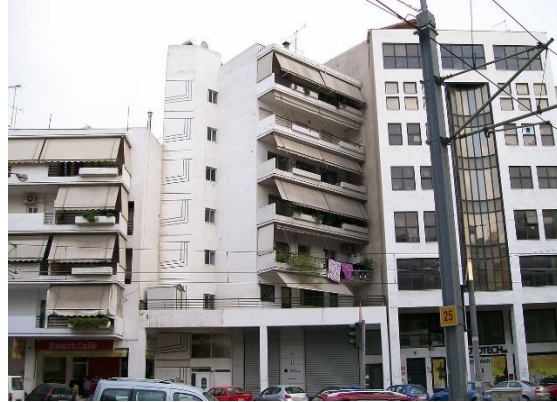
concrete structure

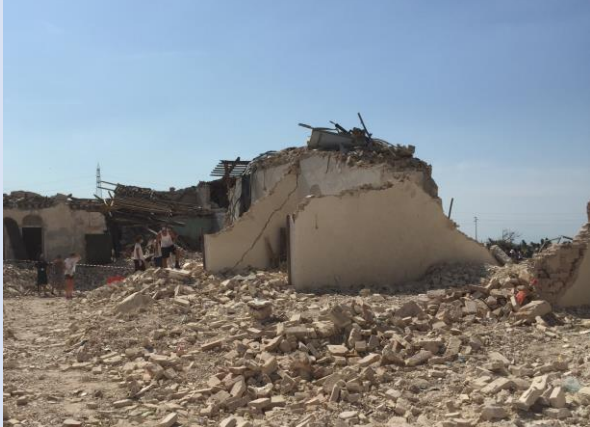
<p><i>Photo: Alois M. Holzer (ESSL)</i></p>	<p>Villa with thick brick walls, but with degraded mortar (class D), has most walls destroyed (DoD=2).</p> <p>Dolo, Italy 8 July 2015</p>	<p>BD/2:≥4</p>	<p>IF4</p>

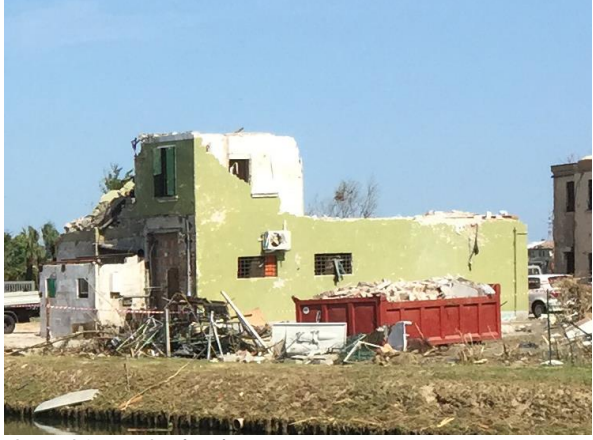
<p><i>Photo: Alois M. Holzer (ESSL)</i></p>	<p>Concrete masonry house (Class E) has partial destruction of walls (DoD=1)</p> <p>Dolo, Italy, 8 July 2015</p>	<p>BE/1:≥4</p>	<p>IF4</p>

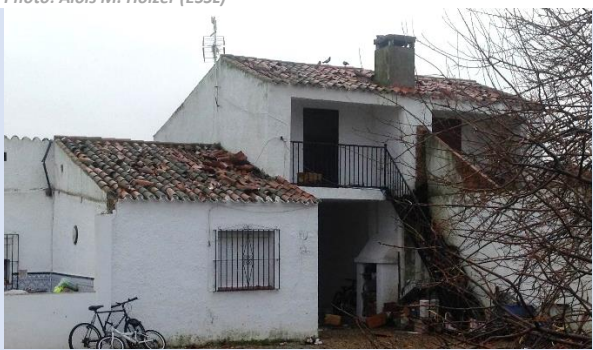
<p><i>Photo: Delia Gutierrez-Rubio & Juan de Dios Soriano (AEMET)</i></p>	<p>House with roof of heavy tiles (T+), has lost a few tiles (DoD=1).</p> <p>La Parilla, Spain, 21 February 2013</p>	<p>BT+/1</p>	<p>IF1-</p>

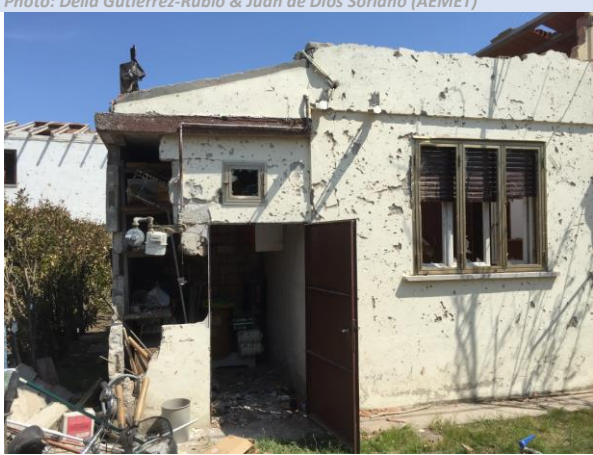
<p><i>Photo: Alois M. Holzer (ESSL)</i></p>	<p>Single-layer concrete block masonry building (Class C) has partial destruction of walls (DoD=1)</p> <p>Dolo, Italy, 8 July 2015</p>	<p>BC/1:≥2+</p>	<p>IF2+</p>

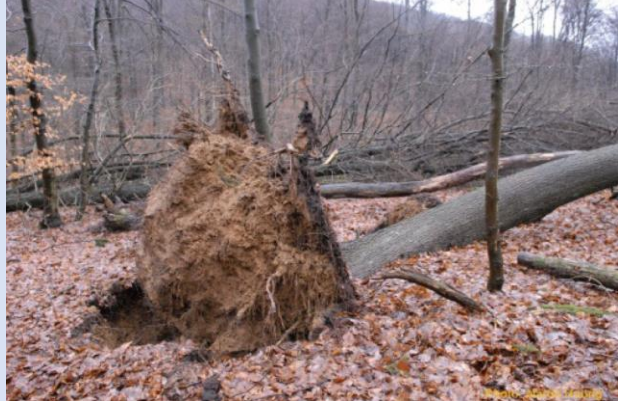
<p><small>Photo: Martin Hubrig</small></p>	<p>An oak (high firmness tree 3) without leaves (T3+), and a typical rooting, (TR4), was uprooted (DoD=1)</p>	<p>TR4/1</p>	<p>IF2-</p>

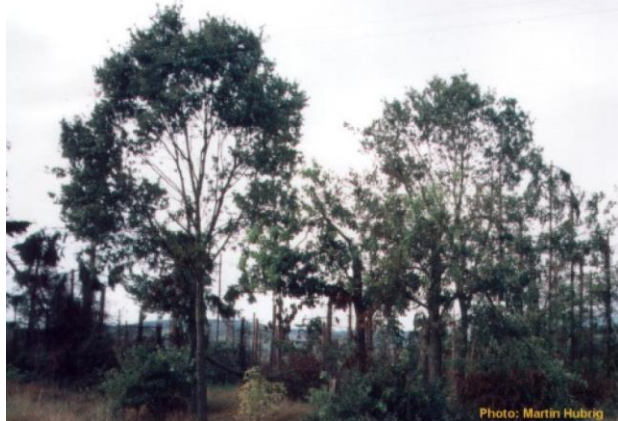
<p><small>Photo: Martin Hubrig</small></p>	<p>An oak (high firmness 3) located at a forest edge (+1) at a very exposed location (+1) (T5) lost some large green branches (DoD=2)</p>	<p>T5/2</p>	<p>IF1+</p>

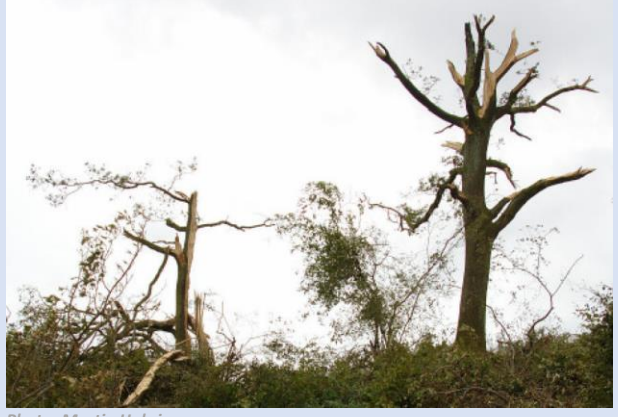
<p><small>Photo: Martin Hubrig</small></p>	<p>An oak (high firmness 3) located at a forest edge (+1) (T4) lost most of its branches (DoD=5)</p>	<p>T4/5</p>	<p>IF3</p>

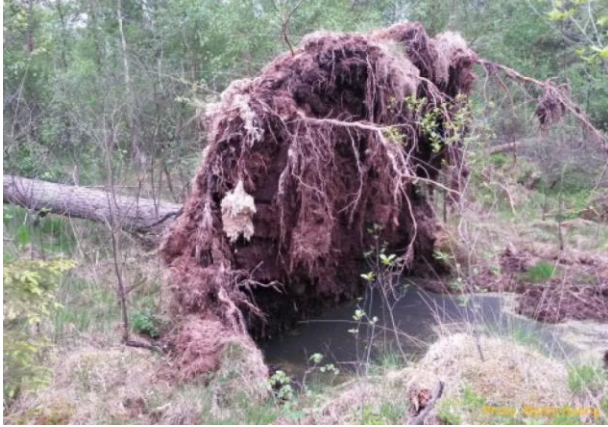
<p><i>Photo: Martin Hubrig</i></p>	<p>A pine with low firmness (T2), poorly rooted (-1), on wet (-1) soil (TR0) was uprooted (DoD=1)</p>	<p>TR0/1</p>	<p>IF0+</p>

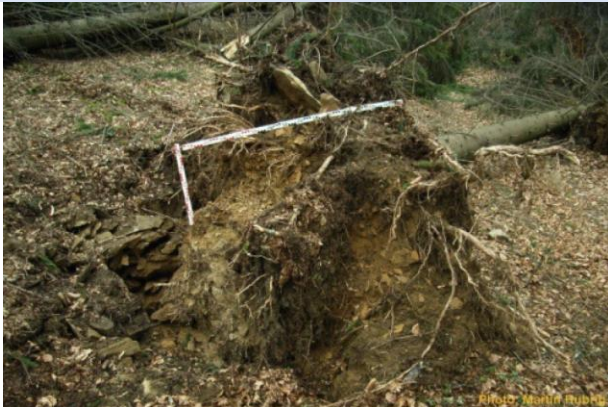
<p><i>Photo: Martin Hubrig</i></p>	<p>A spruce (low firmness 2), standing on an exposed hill (+1 = T3), was very well rooted (+1 = TR4), but still uprooted (DoD=1).</p>	<p>TR4/1</p>	<p>IF2-</p>

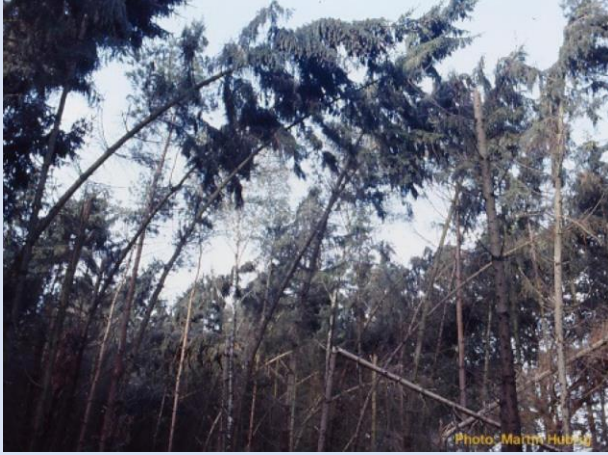
<p><i>Photo: Martin Hubrig</i></p>	<p>Spruces (low firmness 2), with an unstable H/D ratio (-1 = T1), sustained compression failure (DoD=3)</p>	<p>T1/3</p>	<p>IF1-</p>

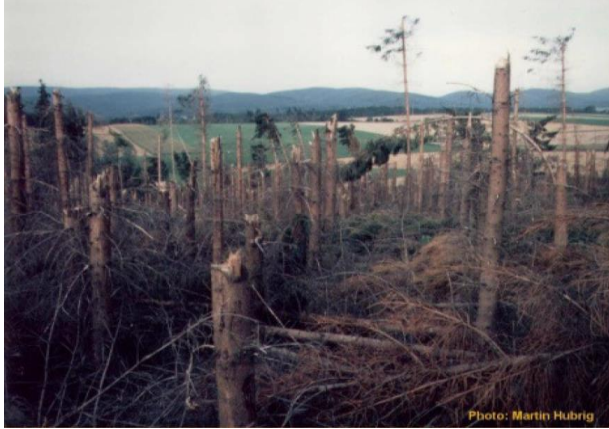
<p><small>Photo: Martin Hubrig</small></p>	<p>Spruces (low firmness 2), with an unstable H/D ratio (-1 = T1) had their trunks snapped (DoD=4)</p>	<p>T1/4</p>	<p>IF1+</p>

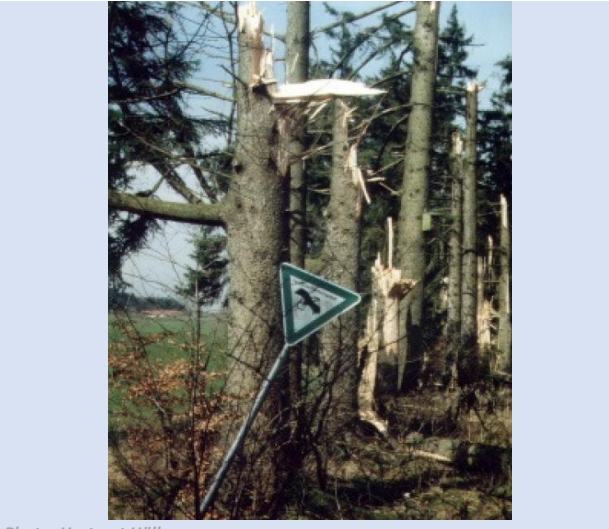
<p><small>Photo: Hartmut Höller</small></p>	<p>Spruces (low firmness 2), edge tree (+1=T3) had trunks snapped (DoD=4).</p>	<p>T3/4</p>	<p>IF2+</p>

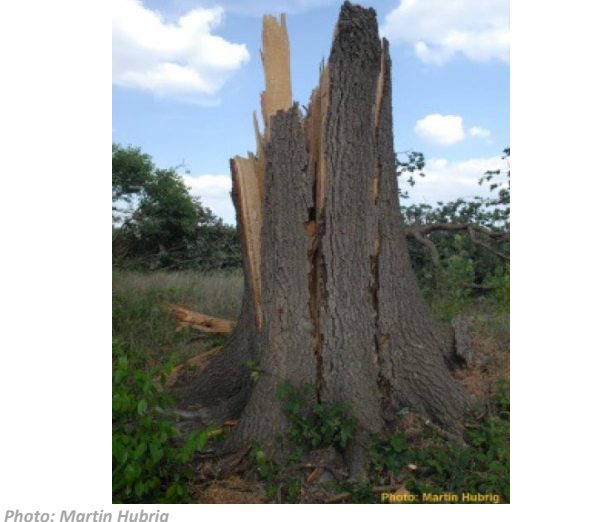
<p><small>Photo: Martin Hubrig</small></p>	<p>An oak (high firmness 3), that was solitary (+1) had a 2/3 rotten trunk (not visible; -2 = T2) that snapped (DoD=4)</p>	<p>T2/4</p>	<p>IF2</p>

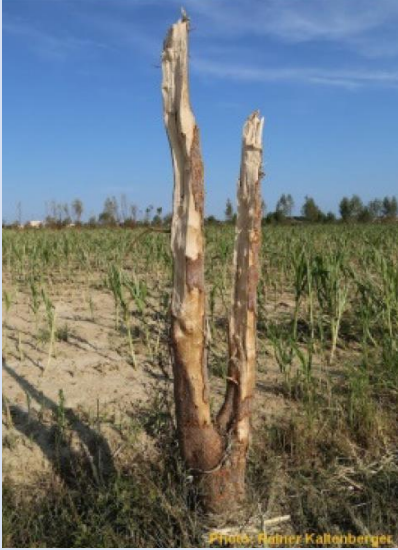
<p>A solitary tree (T unimportant), sustained beginning debarking by sandblasting (DoD=6)</p>	<p>T/6</p>	<p>IF3</p>

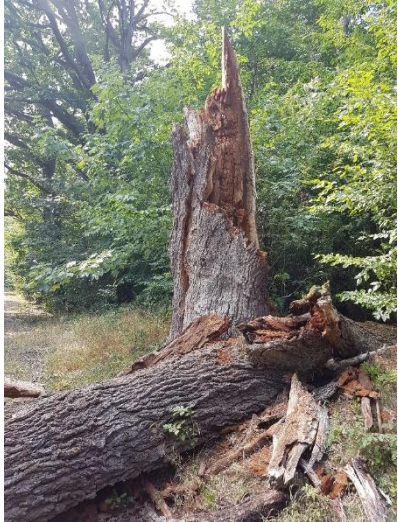
<p>An oak with very bad wood rot (> 2/3 of the trunk section), that cannot be rated.</p>	<p>T/?</p>	<p>?</p>

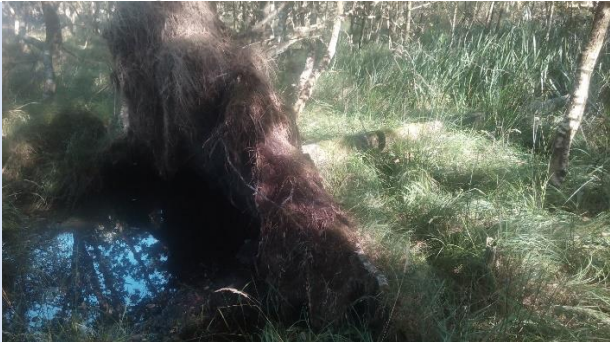
<p>A birch with low firmness (T2), poorly rooted (-1), on wet (-1) soil (TR0) was uprooted (DoD=1)</p>	<p>TR0/1</p>	<p>IF0+</p>
